ARC SURVEYS AS A MEANS TO DETERMINE FIRE ORIGIN IN RESIDENTIAL STRUCTURES

Daniel L. Churchward, Ryan M. Cox & David Reiter, PE

Abstract: Literature searches failed to locate any published research on the validity of arc surveys in the determination of fire origin. This paper will present a statement of the problem, a discussion on the definition of an arc survey, how to properly perform an arc survey, discussion on the best means for documentation of an arc survey, and issues related to evidence gathering of an arc survey. Furthermore, this paper presents the results of two successful experiments to validate arc surveys as a means to determine the origin of a fire.

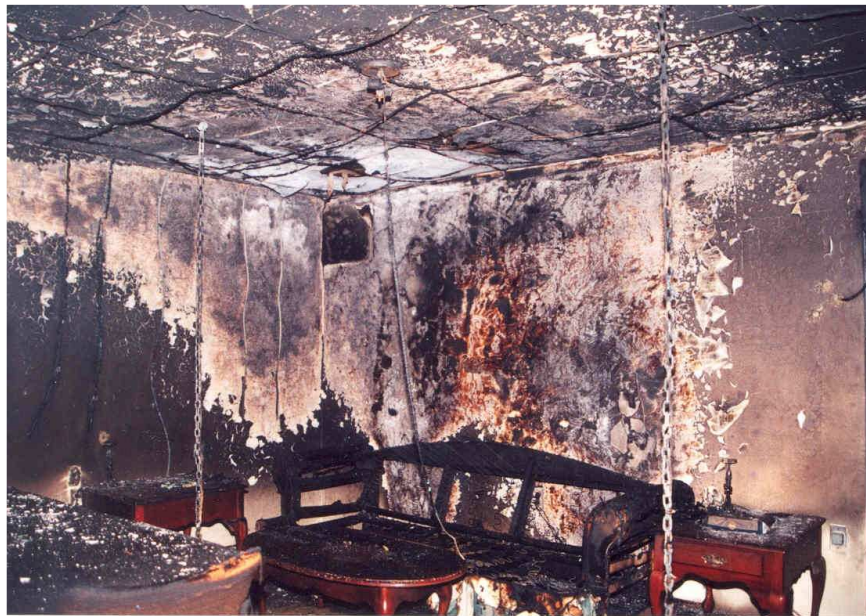
Cells # 2 and 3 burned as expected after modifications to increase ventilation. Each cell was allowed to burn for 12 minutes; neither one reached flashover. Figure 1 shows one of the cells after the burn. The Romex grid is visible on the ceiling. Patterns on the wall behind the couch and the severe calcinations in the corner of the ceiling might suggest that the fire originated in the middle or toward the left side of the couch.

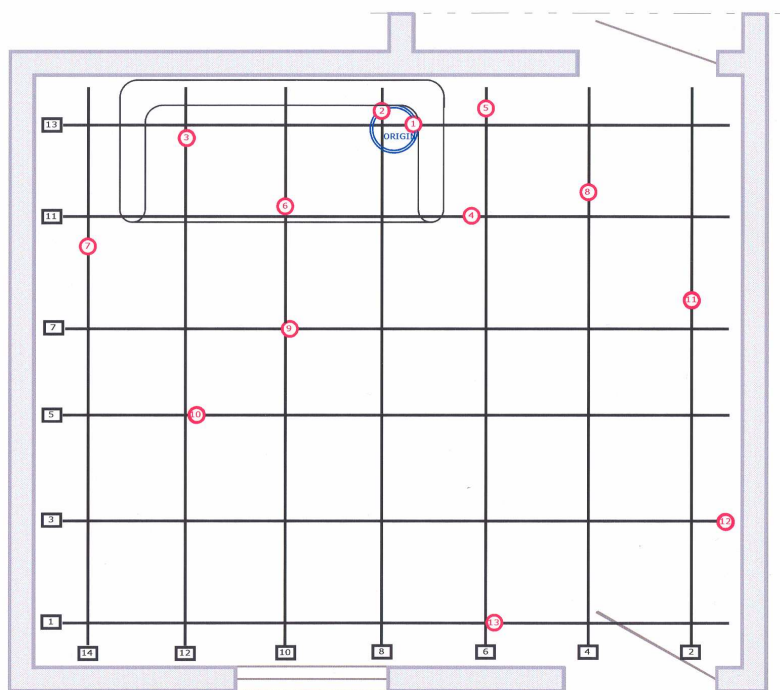
During each burn test, the sequence of circuit breaker tripping was recorded along with the time. That data was ultimately compiled on spreadsheets. All of the conductors in each cell were then carefully examined for evidence of arcing and shorting. When an arc was found, its location was recorded and it was tagged with yellow ribbon. Figure 2 is a plan view drawing of cell # 3 showing the arc locations. The square box at the end of each wire run signifies the circuit number. The circles show the position of each arc and the number inside defines when in the sequence it occurred. Each conductor was then cut down and subsequently examined in a laboratory environment.

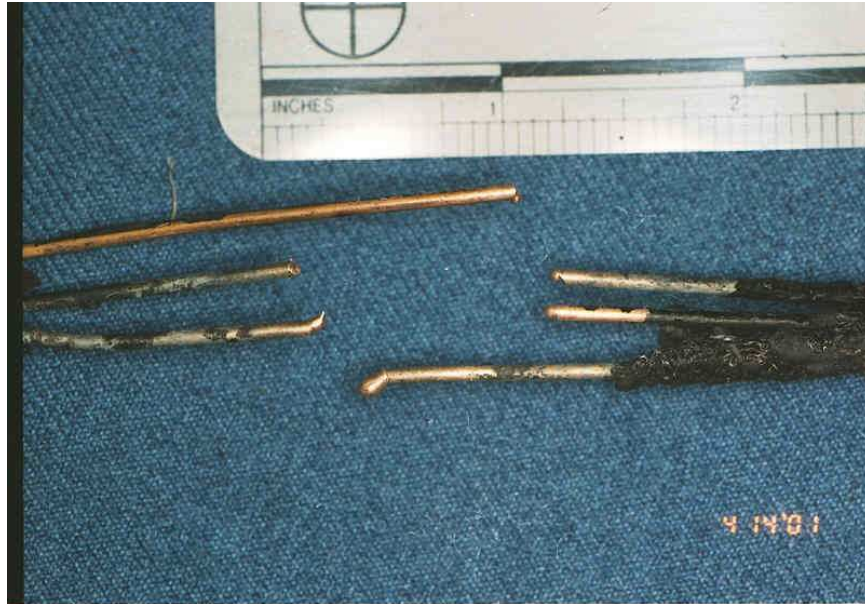
The laboratory documentation consisted of cleaning each site, recording observations and macro-photography. Of particular interest was the varying amount of conductor damage observed even though the circuits were protected by identical breakers and the available fault current remained constant. Figure 3 shows a substantial amount of damage in that the conductors are severed and there is some copper material missing. Figure 4, on the other hand, shows arc damage of an almost imperceptible nature. It was also noted that some of the arcs occurred between a “hot” conductor and a “ground” conductor while others took place between the “hot” and “neutral.” Some arcs involved all three conductors in the Romex bundle.

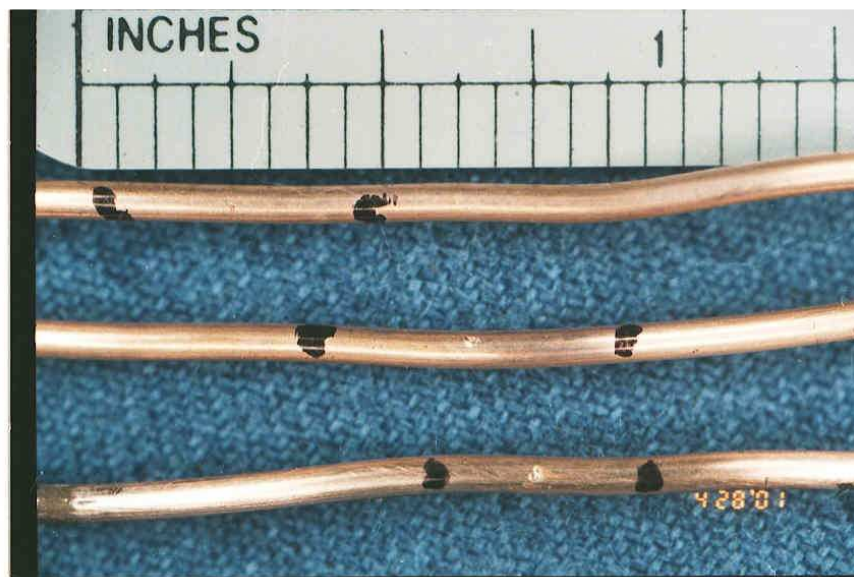
Figure 4

Although one of the three cells self-extinguished, a substantial amount of useful data was developed from the other two. Thirteen arcs were documented in each cell. The location of each arc and its respective time of occurrence bore witness to the fire’s development. The first arcs took place almost directly above the fire’s origin. Subsequent arcs were observed to then occur in a radial dispersion outward from the original fire plume. The sequence of events dramatically characterized a typical fire growth scenario whereby the initial fire plume impacts a localized spot on the ceiling. Then, as the fire grows, a hot gas layer is created that progressed radially outward from the initial impact site on the ceiling. Theories contemplated before the test predicted this same type of arc pattern. Hence, the testing conducted on these two successful fires validated those theories. Additional, more-sophisticated testing should serve to reinforce this “arc survey” concept of fire origin determination.
